State of Utah
Department of Natural Resources
Division of Oil, Gas and Mining
Attention: Paul Baker
1594 West North Temple Suite 1210
Box 145801
Salt Lake City, UT 84114-5801

RE: INSPECTION REPORT, COLOR COPY VIA EMAIL 4/27/06

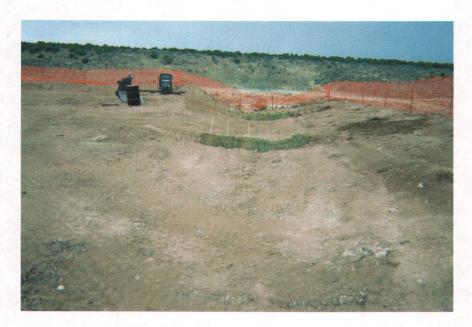
3. Protection of Drainages / Erosion Control
The site is graded such that all drainage would flow to the northeast or southeast corner. No sediment controls have been installed in these areas 9 (Photo 4).

Picture 1: Hay Bales for Sediment Control

We purposely graded the site to control the drainage, with a shallow ditch along the eastern side and north toward the nearest valley. We have now installed two rows of hay bales in the drainage ditch to slow run off from the site, thereby controlling and capturing any run off sediment. We have also installed silt fence along the entire northern berm of the site to control run off from the bermed area. And, finally, we place rip-rap at the far northern end of the drainage ditch to further slow any water running into the valley.

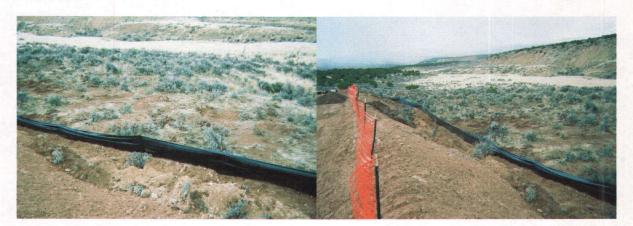
Pictures 2 and 3: Silt Fence along Northern Berm for Sediment Control

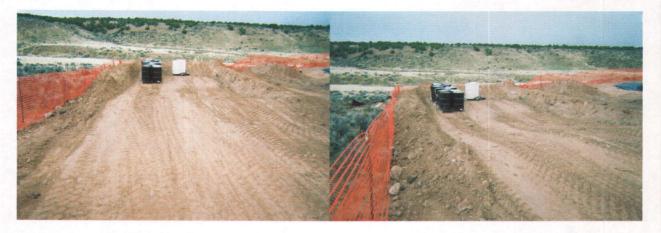
There are several barrels of hexane and pentane being stored on the site, mostly on pallets, but there is no lined or bermed containment area (Photo 1).

Pictures 5 and 6: Solvent Berm

We have built a containment berm for the solvent. This berm is sloped to the north so that we can drive machinery into the berm to pick up the barrels and move them to the processing unit. We have not lined the berm because such lining would undoubtedly get damaged when moving barrels into or out of the berm. We believe there is very little danger of spill in the berm as it is simply a storage area.

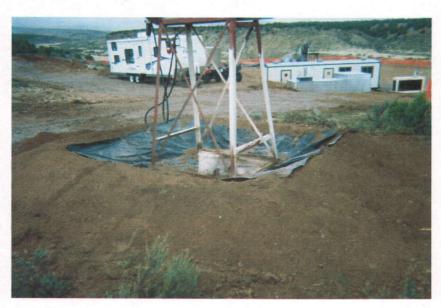
The containment area around the fuel tank does not appear to be large enough to contain the full contents of this tank.

Picture 7: Fuel Tank Berm

We have increased the volume of the containment berm to over 80 cubic feet, which is 1.2 times the total volume of the 500 gallon diesel fuel tank.

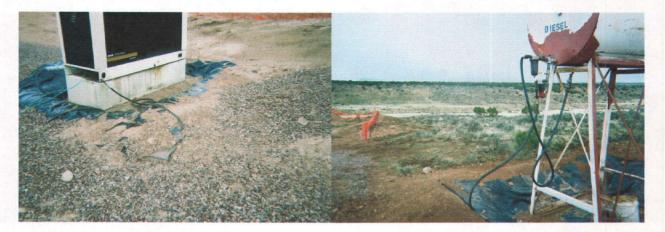
There is a fuel line running from the fuel tank to the generator, and it is exposed.

Pictures 8 and 9: Buried Fuel Line to Generator

We have buried the fuel tank line.

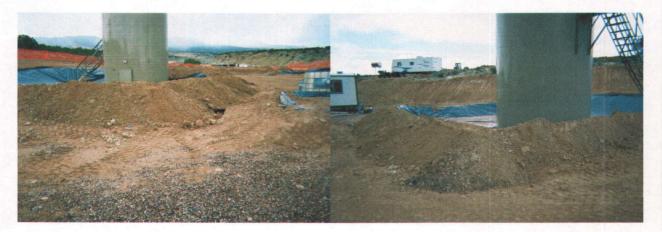
The containment area around the main oil storage tank (Photo 2) does not appear to be large enough to contain the full contents of this tank. Particularly, this containment area is sloped to the southeast, and it appears the southeast corner of this containment area has the lowest berm. There is a drain pipe running from the processing area into the containment area around the main oil storage tank, but if the main storage tank was to leak, oil would flow back into the processing area from which it would escape.

The inside area of the main oil tank storage berm is 30' X 30', and its minimum height was 2.5'. The overall sloping of the site causes a visual illusion, in that the base of the bermed area is actually level. The southwest corner of the berm is much higher than 2.5 feet, but the northeast corner is three feet high. The total volume of the bermed area is 2,250 ft³, which gives a 1.34 safety factor over the 1,683 ft³ volume of the storage tank. Nevertheless, we went ahead and increased the height of the berm in the northeast corner.

Pictures 10 and 11: Oil Storage Tank Berm

We have also removed the drain pipe in question.

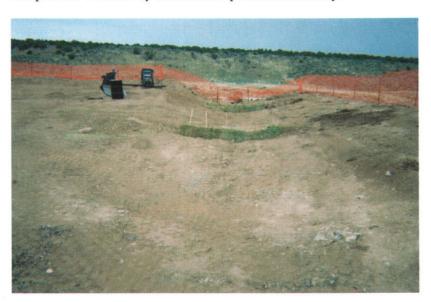
We did not measure the size of the disturbance but estimate it to be about two acres. One small pile of soil has been salvaged (Photo 1). There might also be some soil in the berms, but it appeared the berms were soil mixed with overburden. About six inches of topsoil is available, and with a two-acre disturbance, about 1600 cubic yards of soil should have been saved.

We measured the total area of the disturbance to be 55,930 ft², or about 1.3 acres. At six inches of topsoil that would give about 1,050 cubic yards of top soil. Most of this topsoil was pushed into the drainage containment berm along the eastern border of the site. In addition, there are several piles of topsoil at the site. I am assured by our personnel that they were careful to conserve the topsoil in the berm and piles. Our plan for reclamation of the site includes scarifying or ripping. If we do not have enough top soil to properly reclaim the area after this process we will buy additional top soil as necessary.

Picture 13: Eastern Drainage Berm Made of Topsoil.
